## LP Gas Cylinder Alert

SA012007 – 27/08/2007

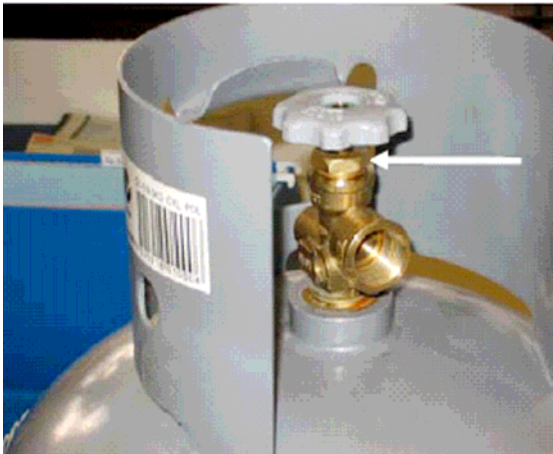
Valve showing loose gland nut

The pictures show the nut which, having a left-hand thread, can be undone during the process of manually turning off the cylinder valve. This may cause the valve assembly to loosen and separate, allowing the immediate release of the cylinder contents under pressure with no real way of stopping the flow once started.

All persons refilling these cylinders are requested to pay particular attention to the tightness of the gland nut. **Remember that this is a left-hand thread and is tightened in an anticlockwise manner.**

All valves on Chinese manufactured cylinders should be checked as a matter of course and any loose nuts found reported to this office. Tightening should ensure that the valve gland nut is well-secured in place. **IF IN ANY DOUBT, DO NOT FILL THE CYLINDER.**

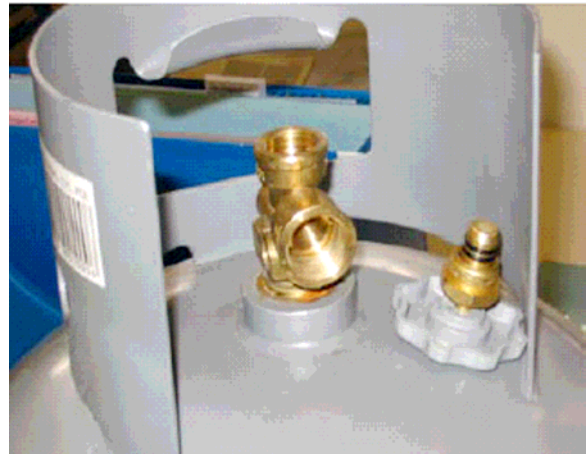
Valve can fall apart during closing action
