Accidental use of solid links instead of indoor service fuses

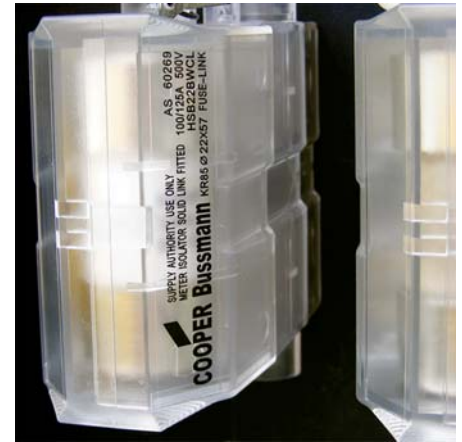
The last incident involved three Cooper Bussmann HSB22BWCL KR85 22 X 57 mm Fuses fitted with solid links. The fuse carriers were labelled “supply authority use only” and “meter isolator solid link fitted”. The labelling may be seen as confusing and could have led to the misuse. However, no matter what the labelling says, **solid links are NOT to be used in the Northern Territory.**

The accidental use of solid links removes this protection potentially exposing the installation to a serious fire risk, and the occupants to electric shock.

Before installing indoor service fuses ensure they are the correct type and are designed to accept 22 x 57 mm service fuses as specified by Power and Water Corporation [Metering Manual](#).
